NATIONAL BUREAU OF STANDARDS REPORT

10 961

FIELD INVESTIGATION OF THE NATURAL GAS PIPELINE ACCIDENT AT CANTERBURY WOODS, ANNANDALE, VIRGINIA

Robert W. Beausoliel, Clinton W. Phillips, and Jack E. Snell

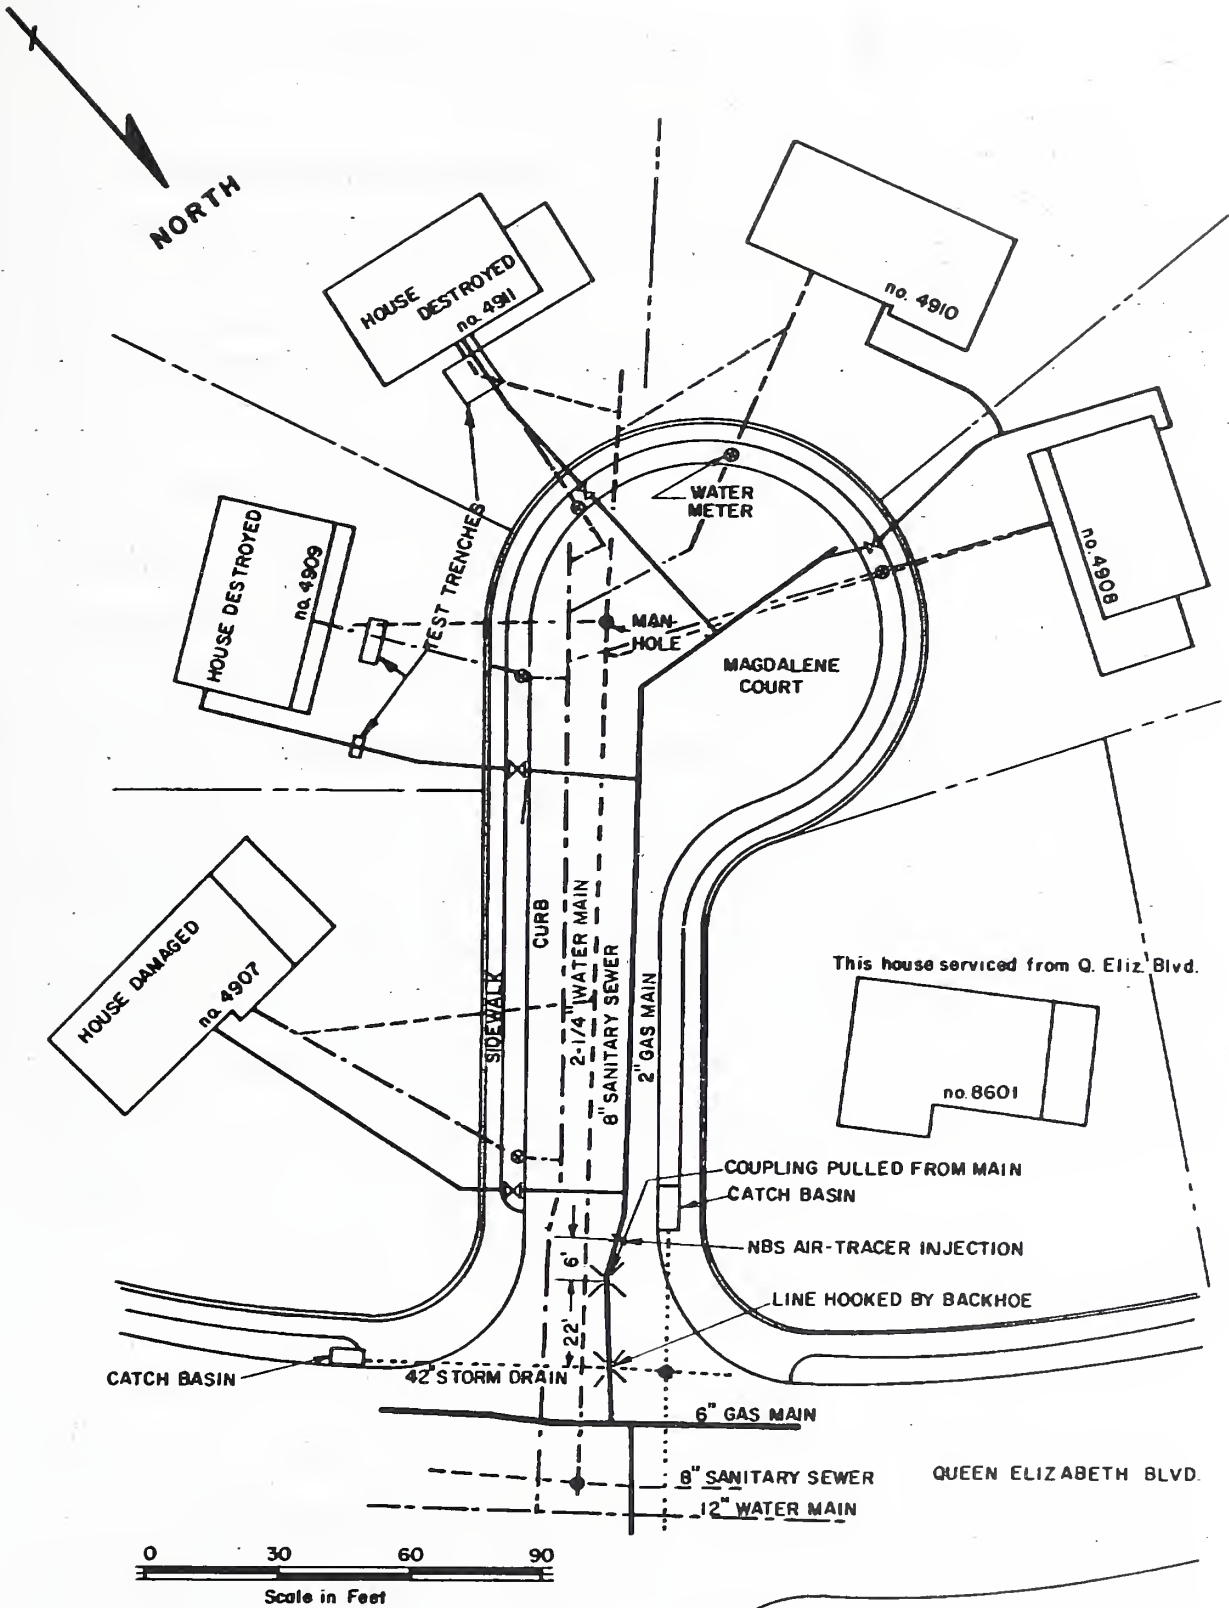
- a. At 7:55 a.m., during the process of excavating for storm sewer pipe replacement for Queen Elizabeth Boulevard, a contractor's back hoe hooked a 2-inch, schedule 40, steel gas main serving five houses on South Magdalene Court, as indicated in Figure 1.

Figure 1. Accident Site.

- a. Expansion joint between driveway and carport concrete slabs at 4907.
- b. Crack in the concrete gutter in front of the water meter box at 4909.
- c. Blacktop and concrete gutter interface located about three feet north of the catch basin adjacent to 8601 at the corner of South Magdalene Court and Queen Elizabeth Boulevard.

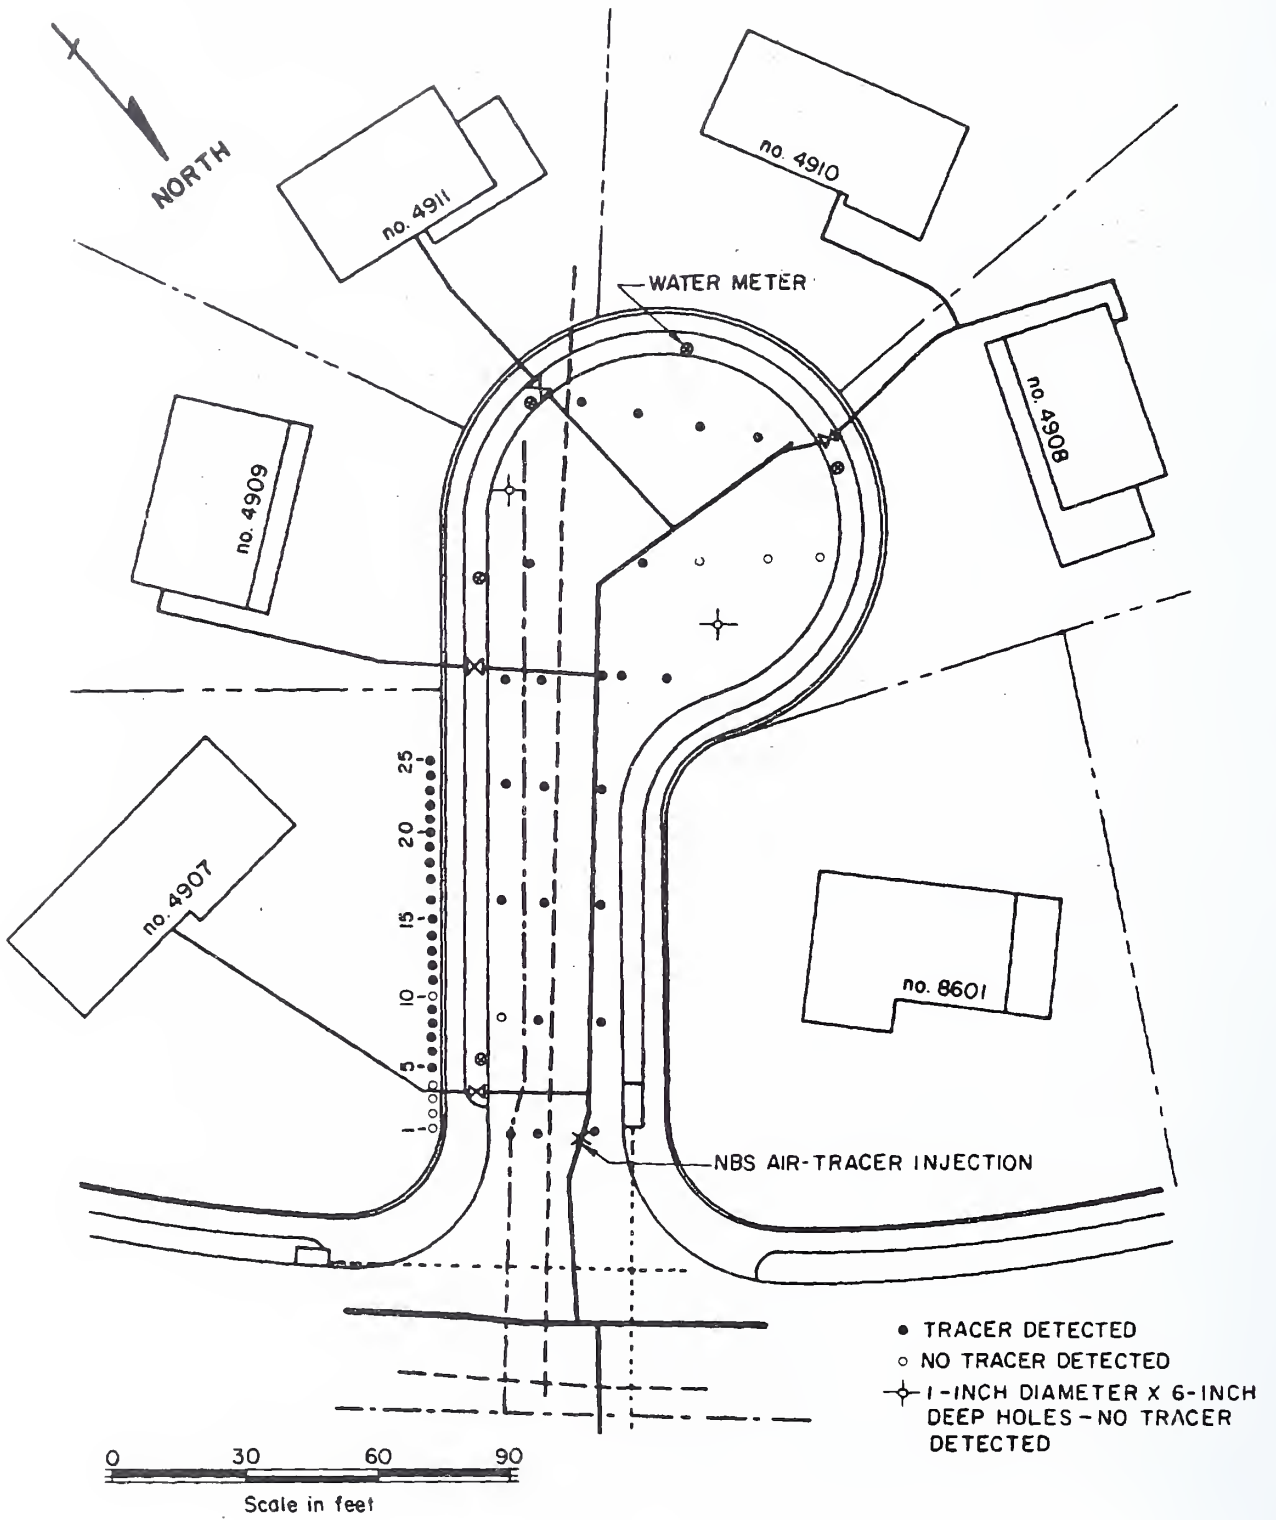
Figure 6. Network of drilled test holes.

The Fairfax County soil analysis sheets for Magdalene Court show only sub-base soil condition (approximate depth 10 inches) and do not show soil or fill condition beneath the sub-base. The drill hole pattern showed that tracer existed generally under the entire right-of-way surface at or above a depth of 2 feet. If a record of type of fill materials used in each utility trench and the depth below the right-of-way that these materials are located had been available, a better judgment could be made concerning the probable distribution paths of tracer in light of the tracer pattern recorded over the plan view of the right-of-way.

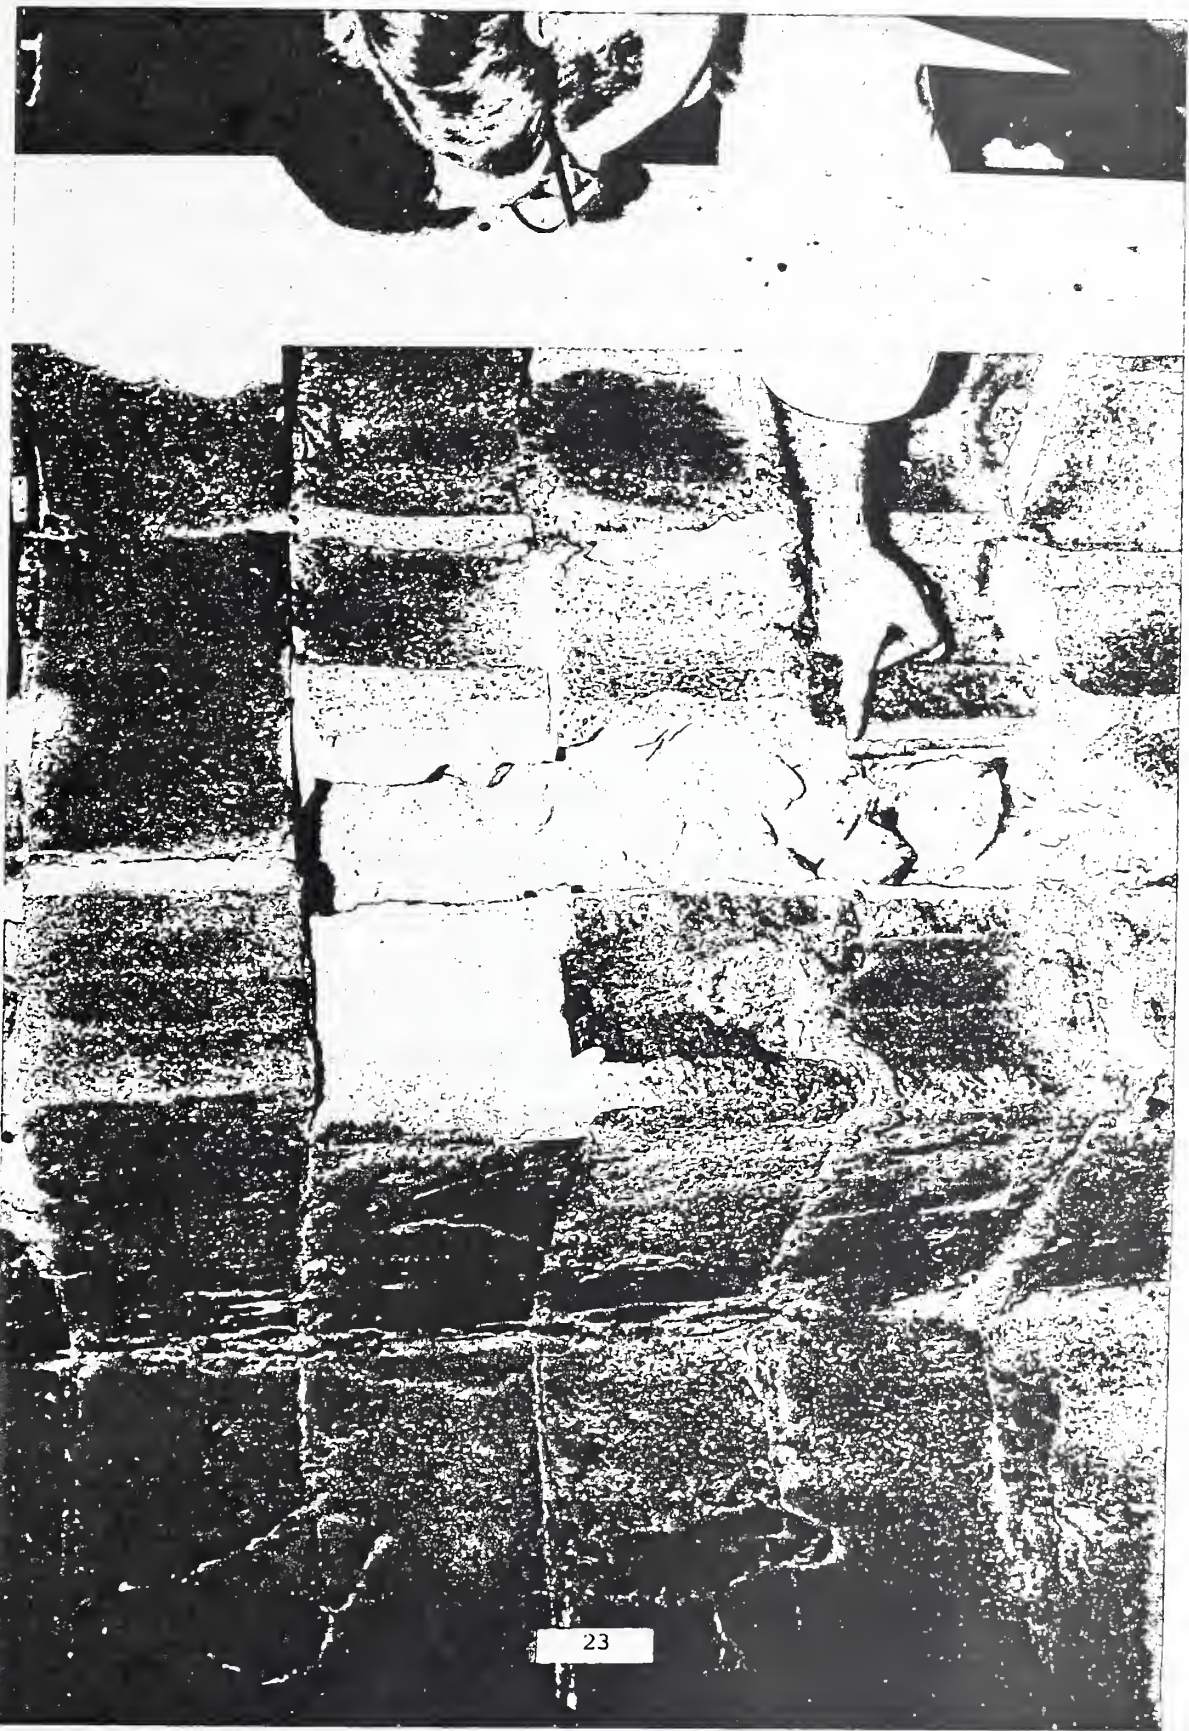
Figure 8. Rock rubble against the foundation wall at 4907.

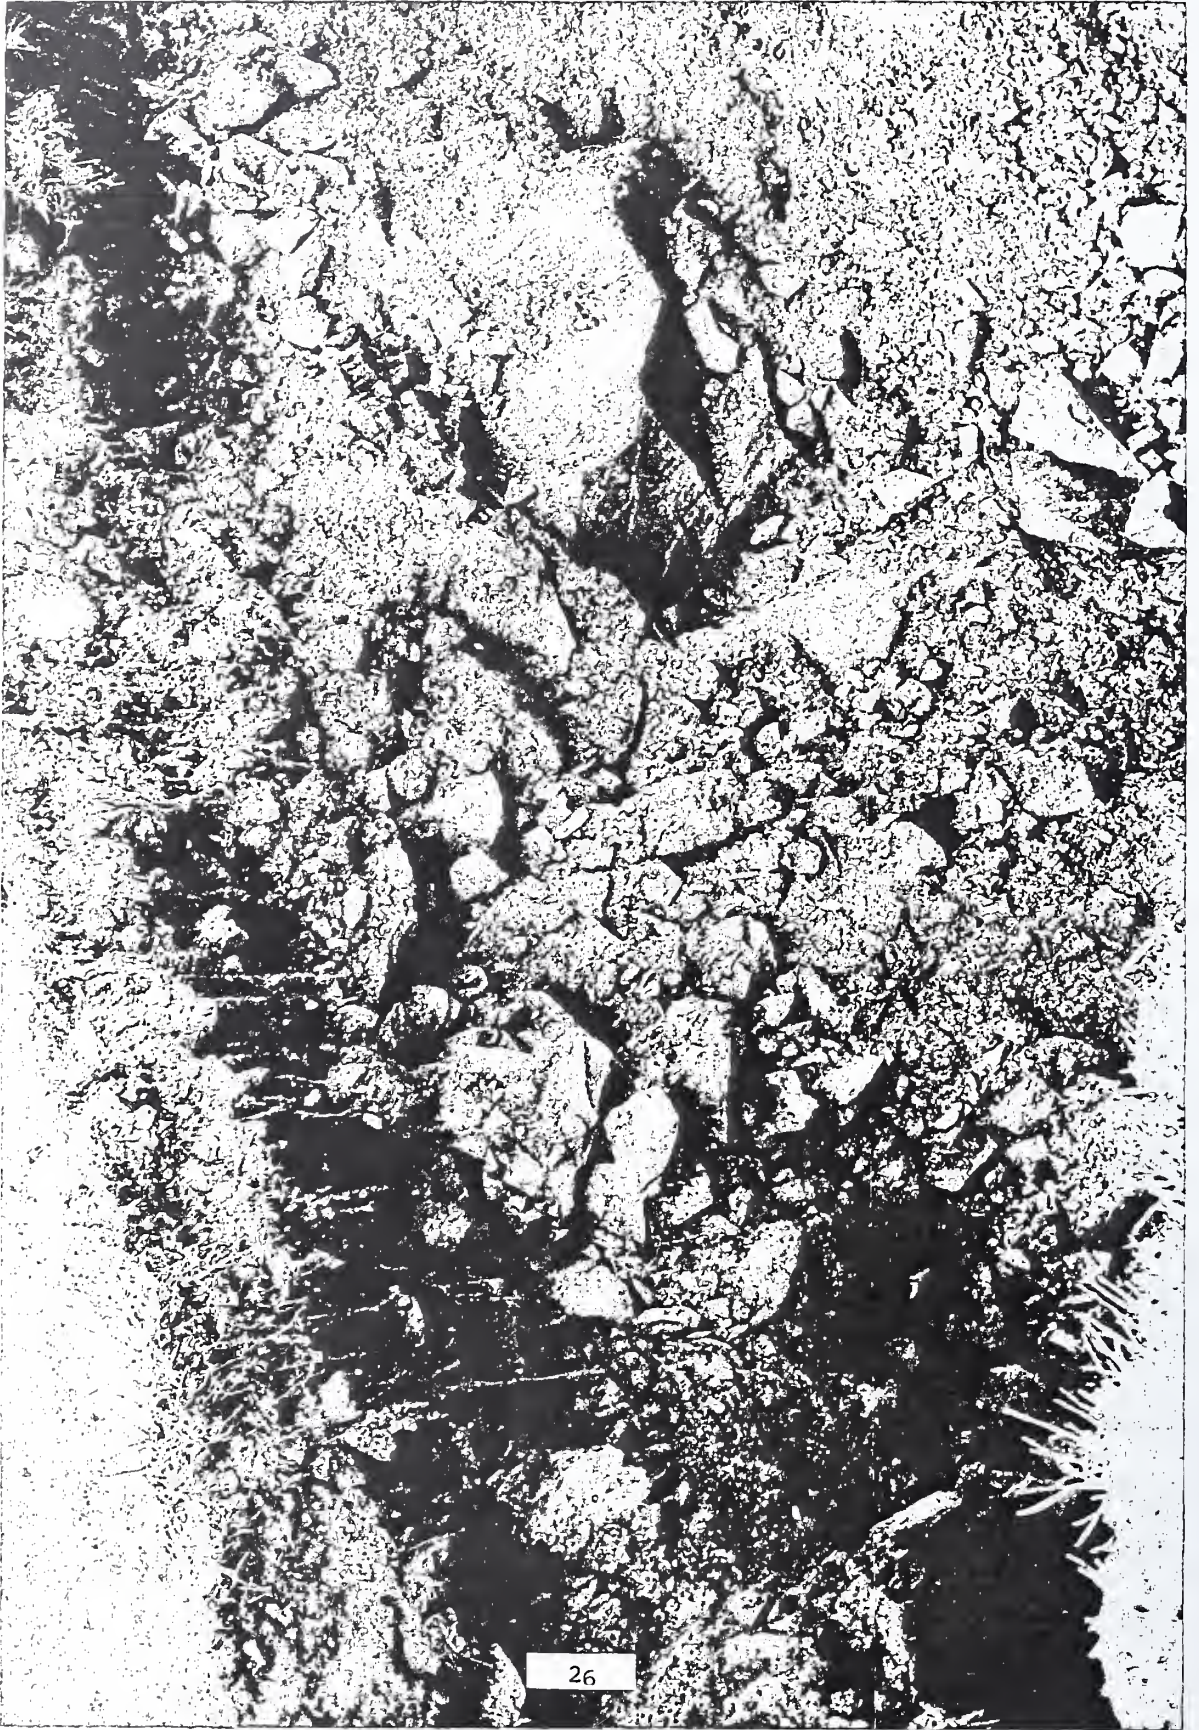
The test trenches in front of 4909 and 4911 contained much rock rubble. See Figures 9 and 10. This rock rubble consisted of loosely-placed rock backfill. The Federal Highway Administration's report containing results of rock-soil samples is attached as Appendix 7.3. This report shows that the trench at 4909 containing the water and sewer lines had fine soil to a depth of 0.4 of a foot, coarse angular rock

Figure 9. Rock rubble in the water and sewer service trench at 4909.

fragments loosely placed as backfill between 0.4 and 5.8 foot depths, and at 6.8 foot depth a fine soil existed. In other words, the rock fill of five inches or greater sieve-size was sandwiched between layers of fine soil material in the 4909 water and sewer line trench. The water/sewer lines were covered by about six inches of rock-free fill in this trench but rested directly on rock fill. No tracer was detected in the immediate vicinity of the water/sewer lines. The water line was beside and below the sewer line.¹ (See Fig. 10.) Water line depth was 69 inches below grade and sewer line depth was 63 inches. No tracer was detected in the gas line trench at 4909. Appendix 7.3 shows that this trench contained a mixture of fine soil and angular rock fragments. The gas line was bedded in rock-free fill and covered with rock-free fill about eight inches deep. The gas line depth was about 24 inches.

- d. Natural gas could flow again into or to the same homes if another natural gas leak were to occur in the vicinity of the leak of March 24 unless the rock rubble paths are eliminated.

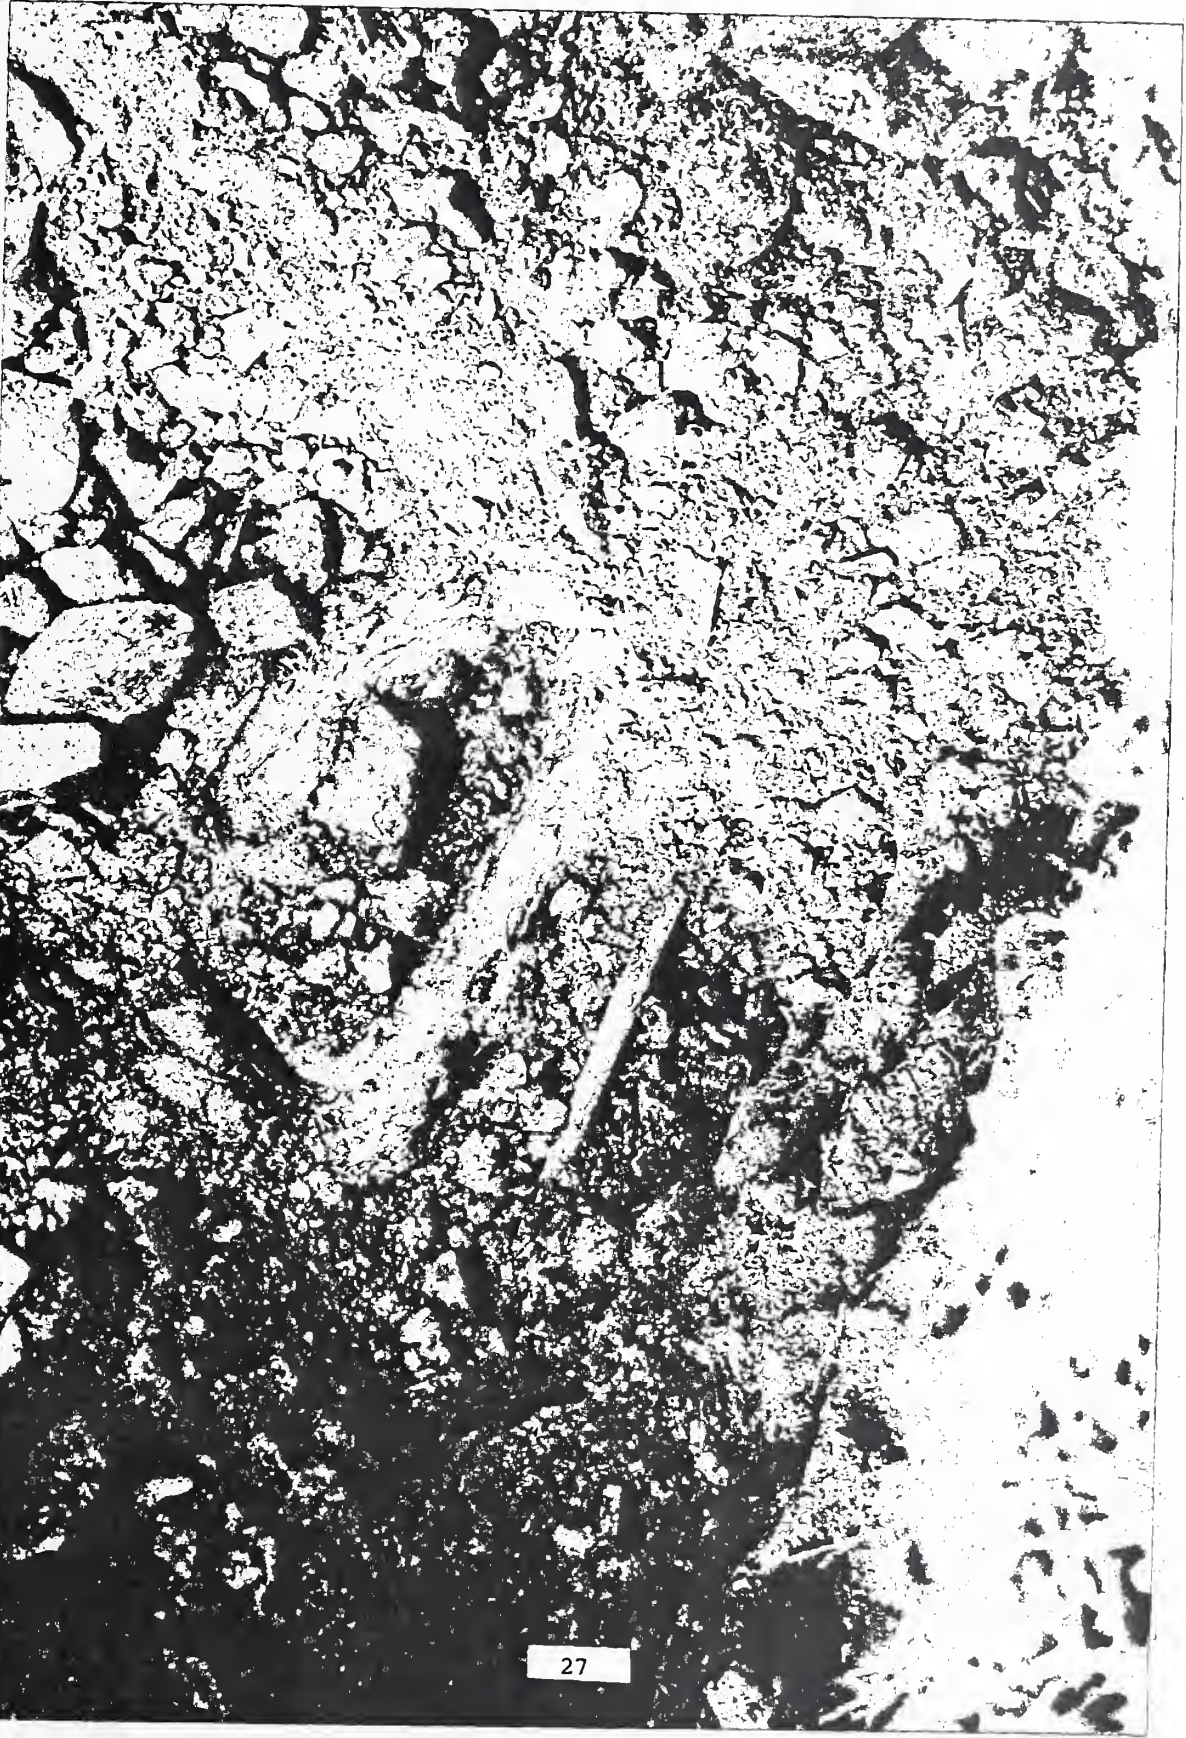
Figure 10. Rock rubble bed for water and sewer services at 4909.

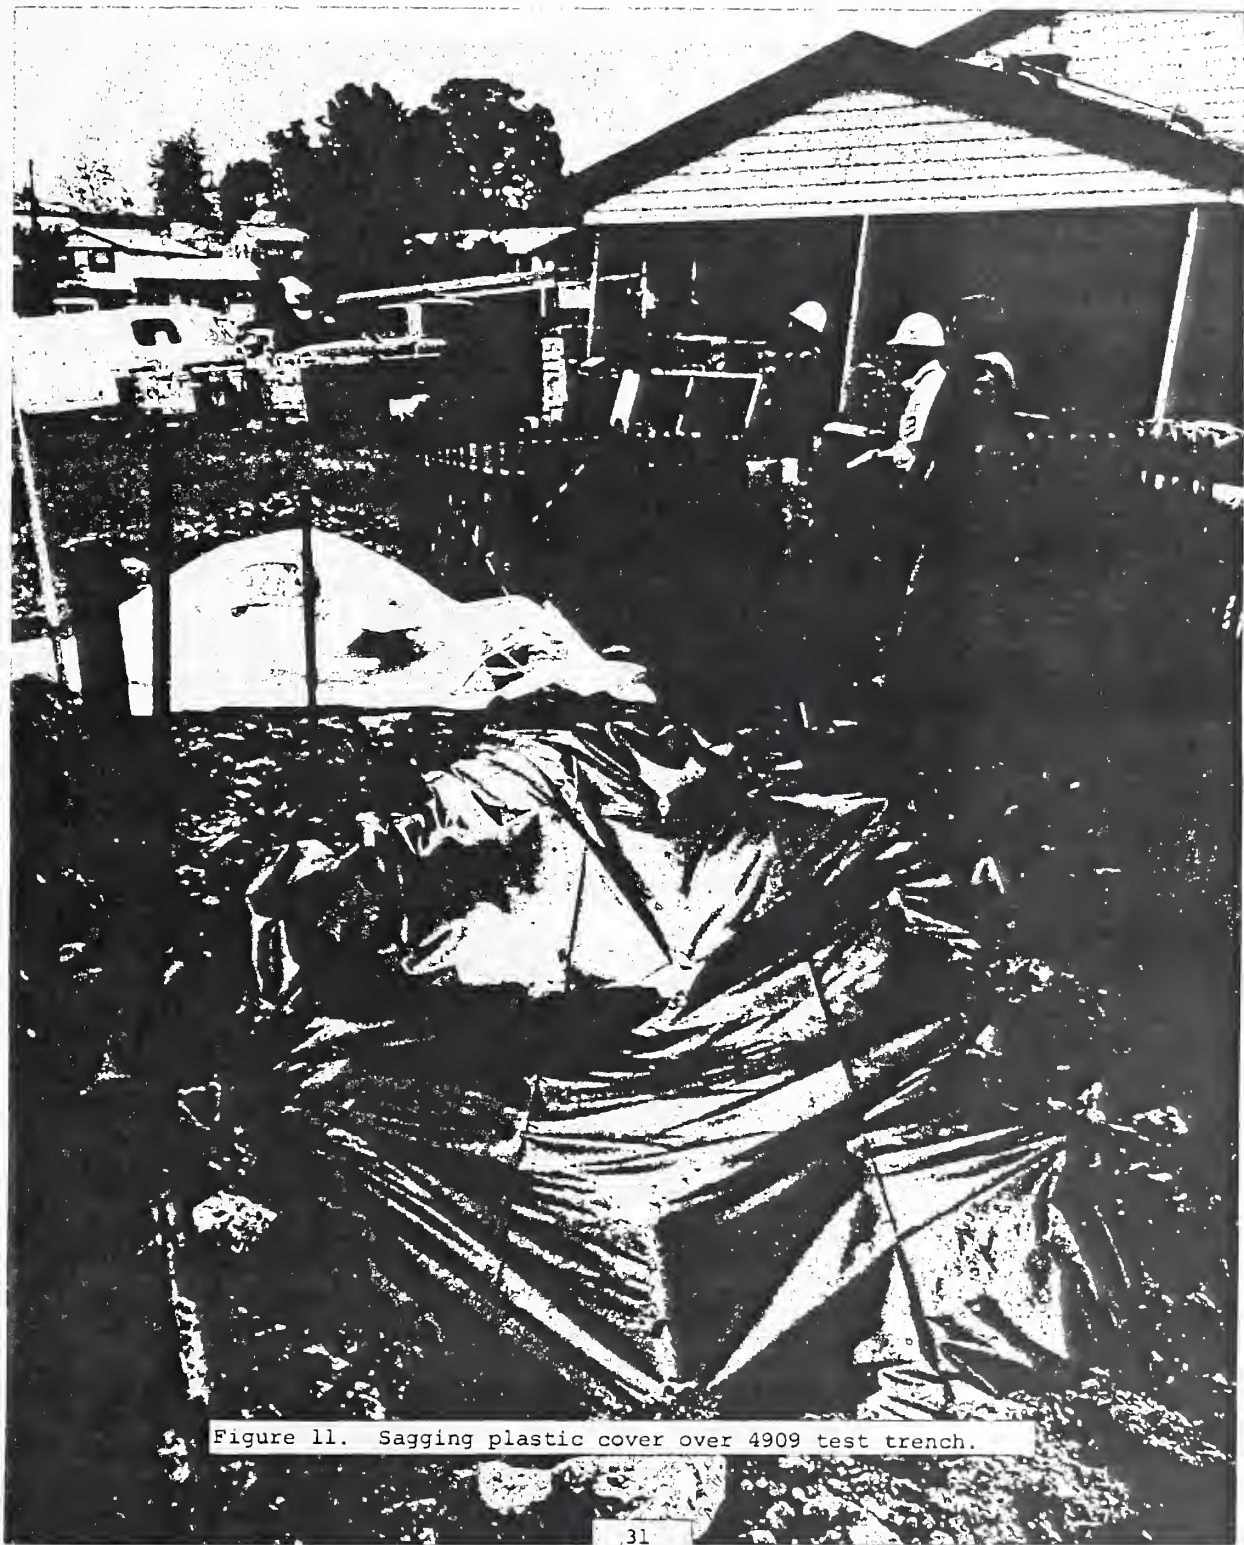
In the quantitative air flow test at 4909, with the vacuum pump off, air tracer entered the trench through the rock fill and caused the plastic cover sheet to be forced up. With the vacuum pump operating at a measured maximum capacity of 15.0 cfm, this capacity was not sufficient to cause the plastic cover to collapse. A micromanometer indicated a varying positive pressure of up to 0.02 inches W.G. (water gage) in the trench with the pump running. To determine if a slight wind was affecting this observation, the vacuum pump and the air supply to the street cavity were turned off. The plastic cover sagged into the trench within one

This test indicates that the air-tracer flow into the trench was in excess of 15 cfm. Also, this air flow test showed that the air-tracer readily passed through voids in the rock rubble from the injection point 150 feet away to the front of the foundation wall at 4909. Air flow at the injection point was 41 cfm and cavity pressure was 3.5 psig at the time of this test.

Figure 11. Sagging plastic cover over 4909 test trench.

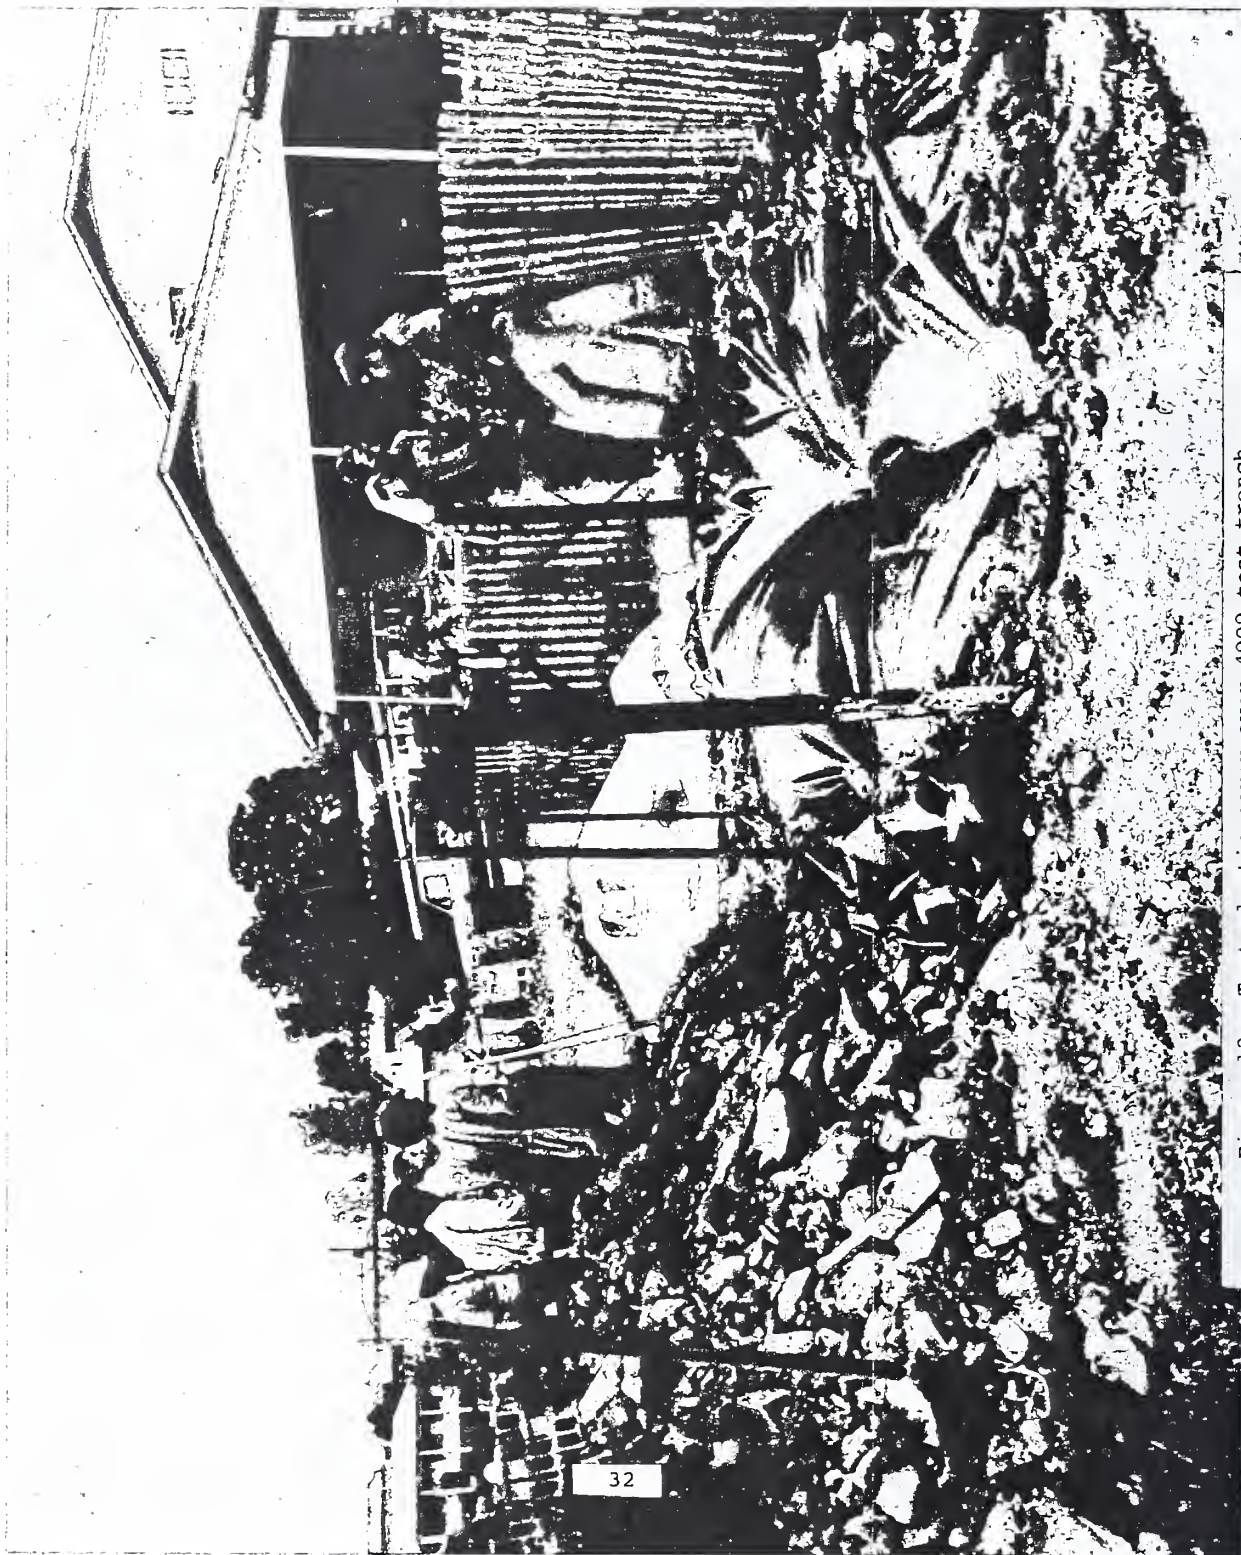
Figure 12. Taut plastic cover over 4909 test trench.
